Rimkus Consulting Group, Inc.
Eight Greenway Plaza, Suite 500
Houston, TX 77046
(800) 580-3228 Telephone
(713) 623-4357 Facsimile

Re: RCG File No: 11009971
LLV Number: 0209452
VMF Location: 1530 Greensmark Drive in Houston, Texas
Subject: Final Report

Rimkus Consulting Group, Inc. was retained to examine LLV 0209452, VIN 1GBCS10E4M2908832. The fire occurred on June 13, 2016 at around 12:30 P.M. the operator of the vehicle at the time of the fire, was unavailable for interview but reportedly stated the vehicle's engine died while delivering mail on his route and backfired during subsequent attempts to restart it. Soon thereafter, smoke was observed from beneath the hood as well as flames.

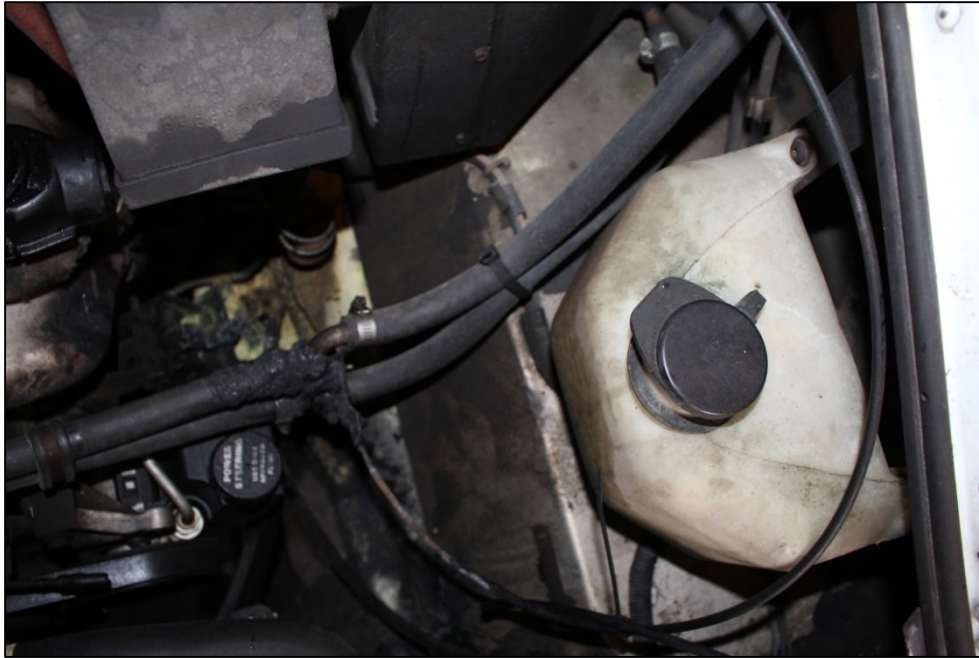
Photograph 13

View of the area of origin.

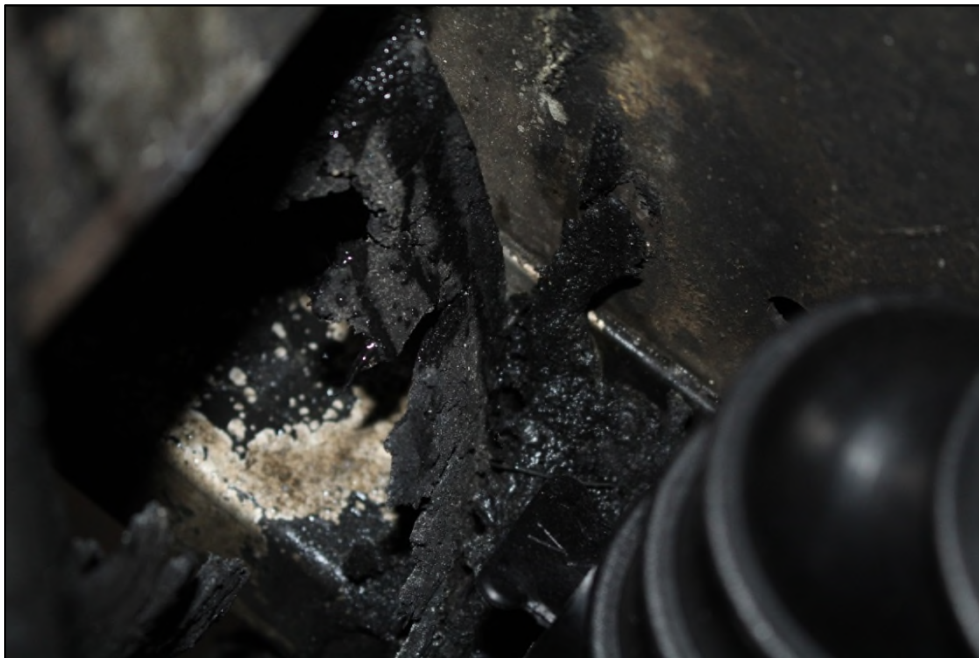
Photograph 14

View of the fire damage to the wheel cover shroud.

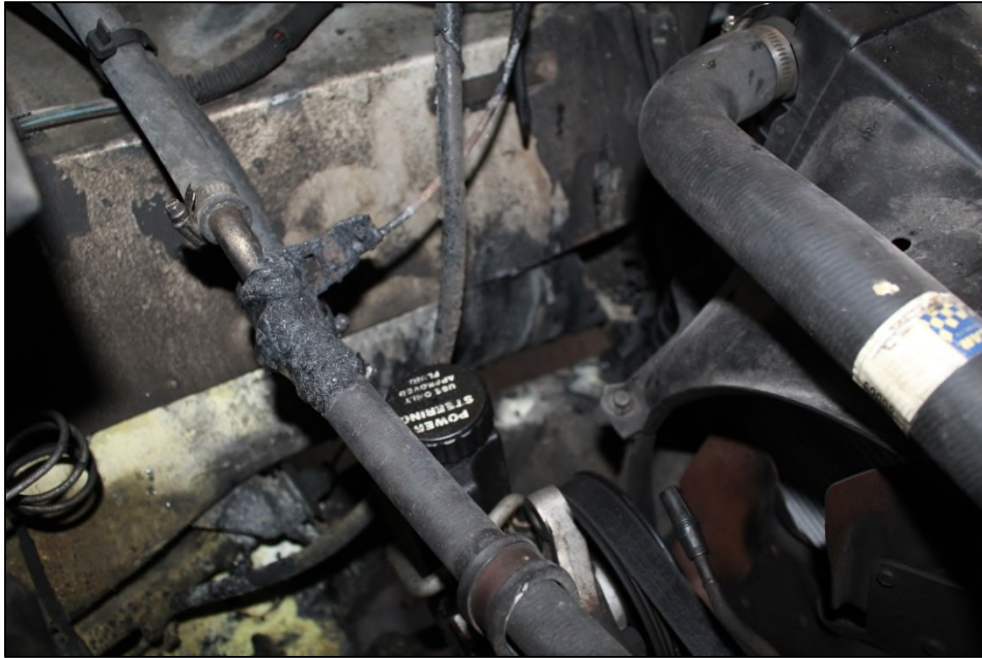
Photograph 15

View of the area of origin.

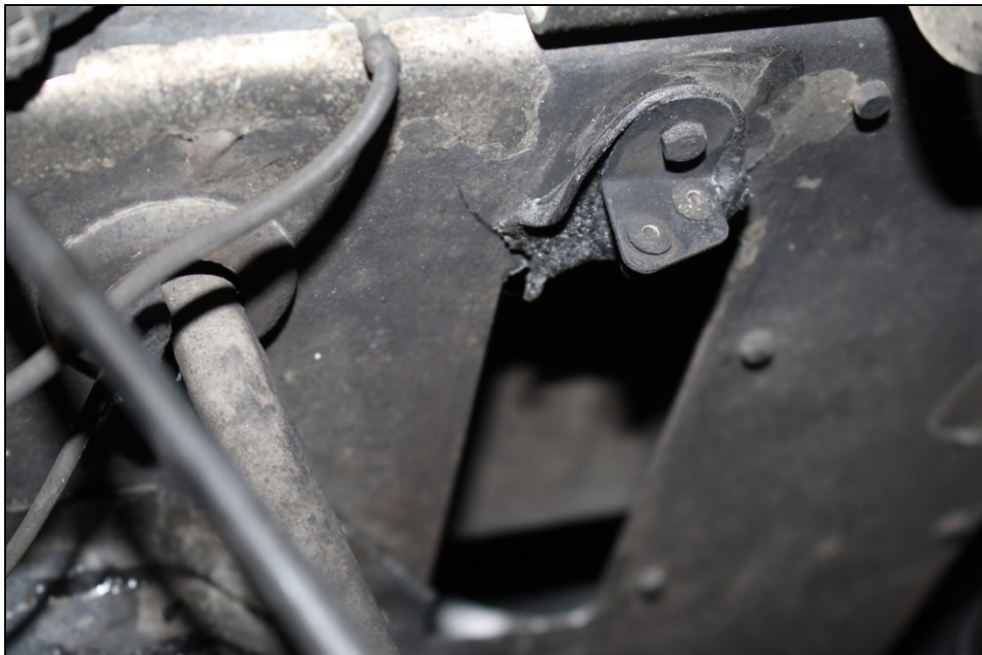
Photograph 16

View of the bracket that holds the plastic air filter shroud to the front section of the engine compartment, there is melted plastic on the bracket.

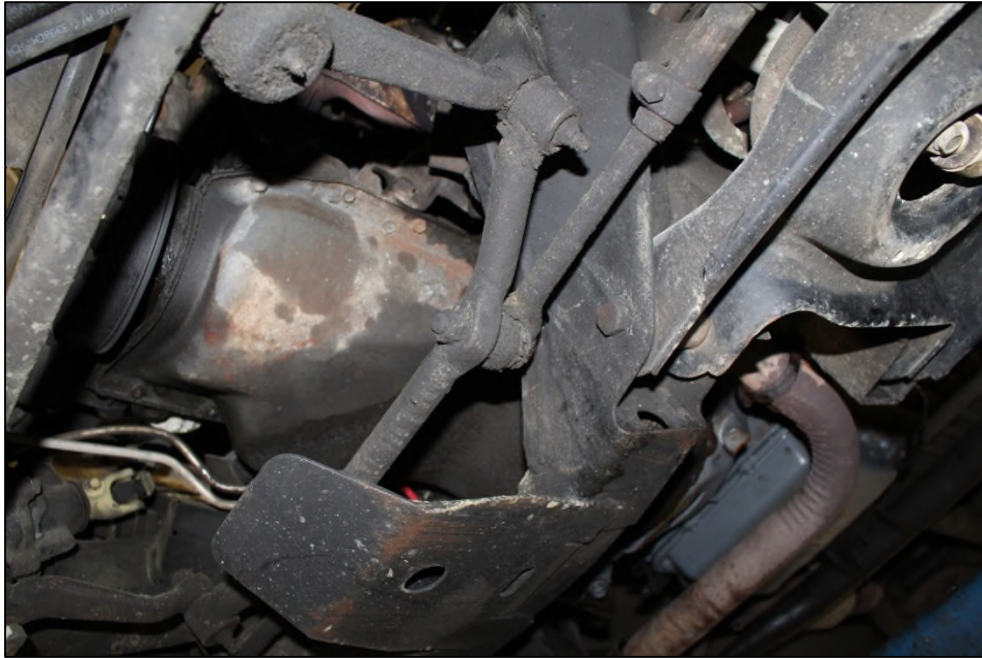
Photograph 19

View of the heat pattern on the left side of the engine.

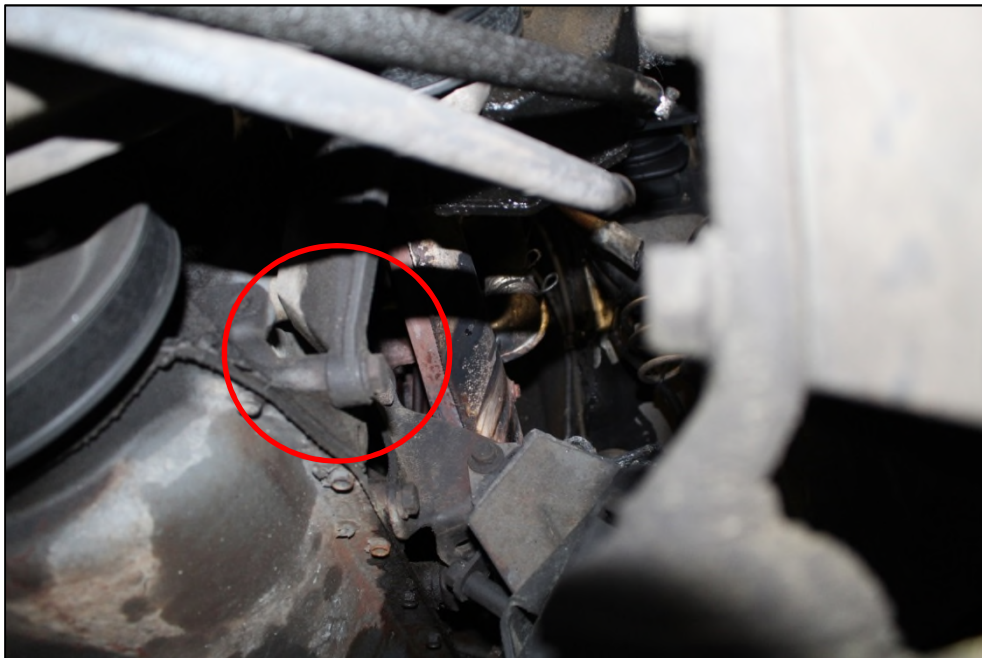
Photograph 20

View of the dark pattern on the manifold.

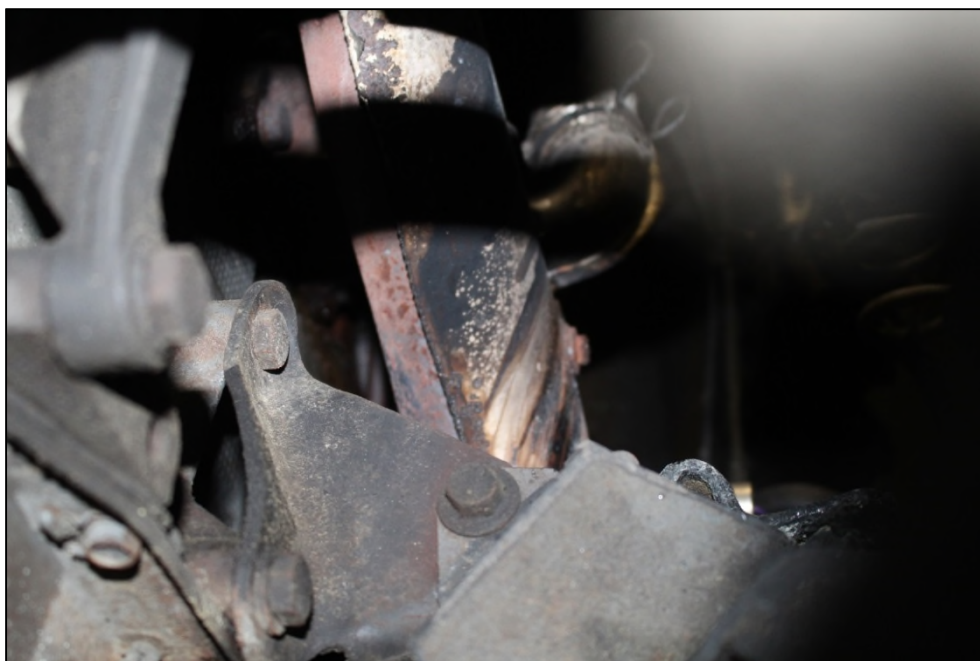
Photograph 21

Close-up view of the dark pattern on the manifold.

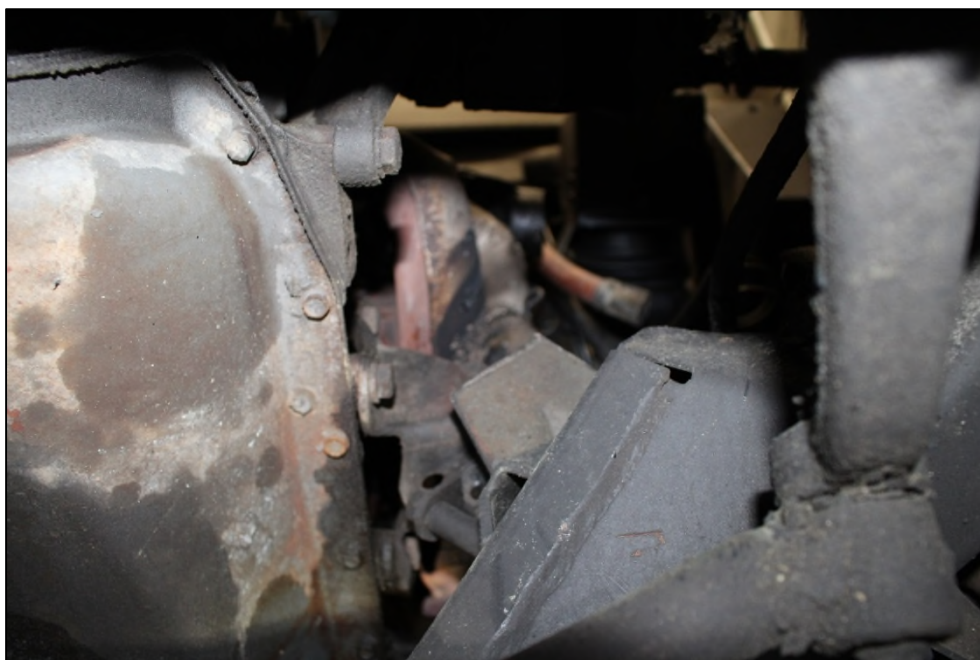
Photograph 22

View of the dark pattern on the manifold.

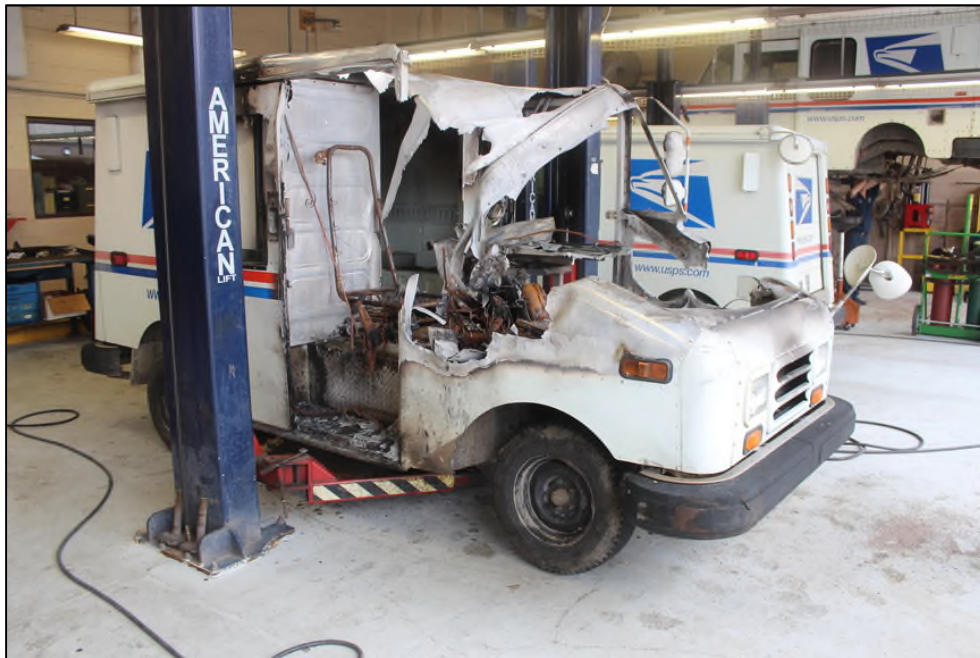
Photograph 2
Driver side with fire damage extension from the engine compartment.

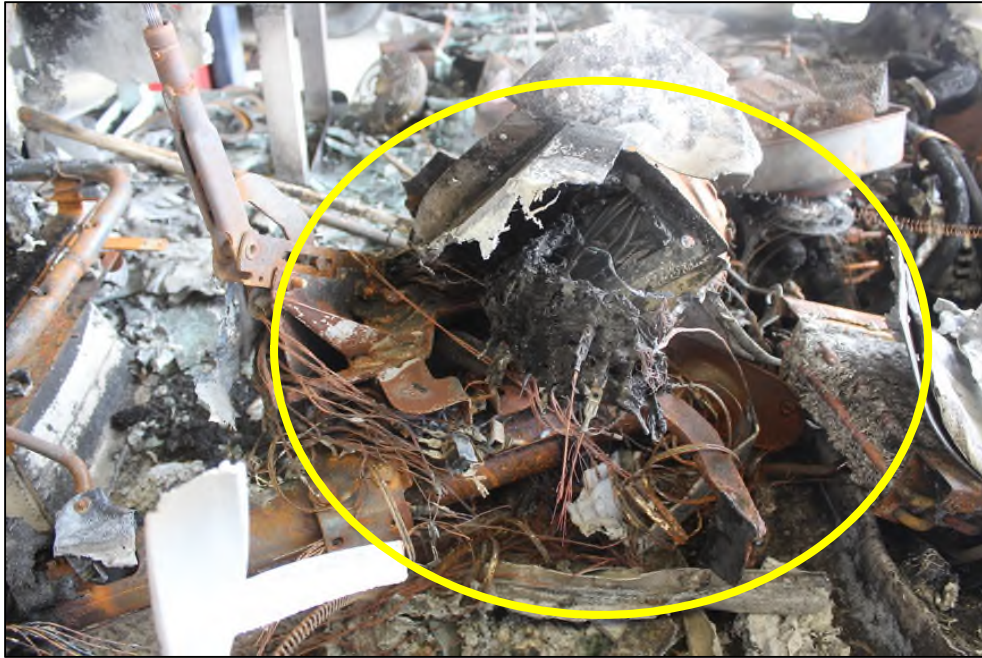
Photograph 4

Fire damaged remains of fuse panel and dashboard.

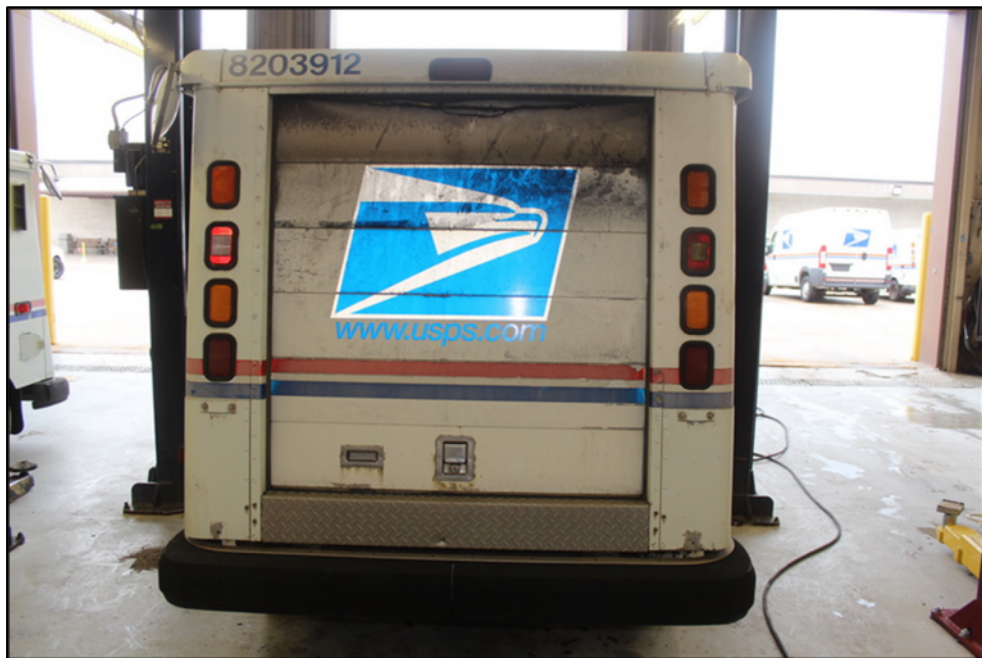
Photograph 5

Rear of LLV with smoke staining on exterior.

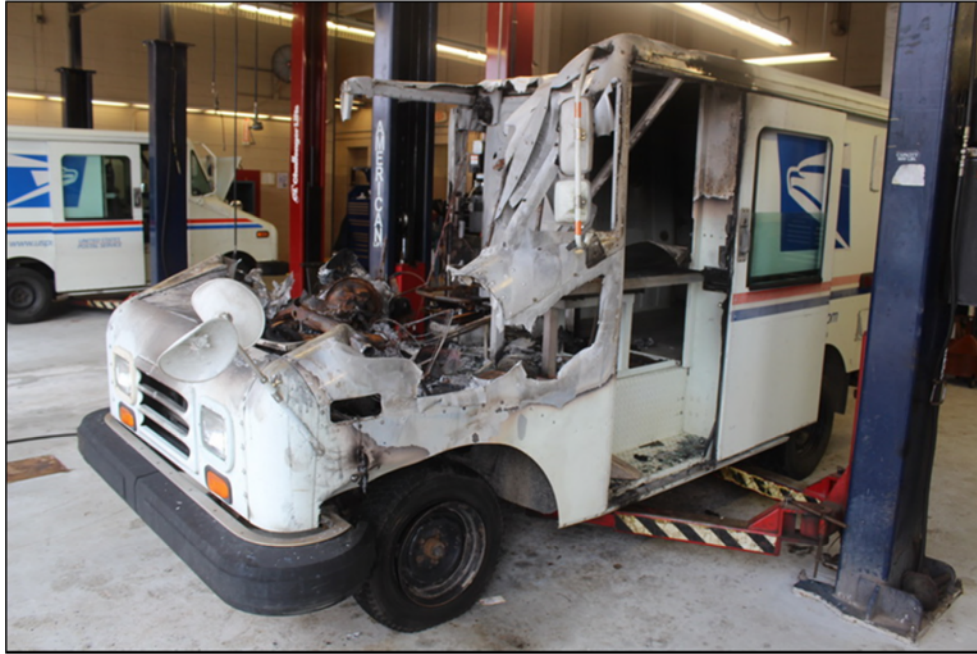
Photograph 6

Mail side of LLV with fire damage extension from the engine compartment.

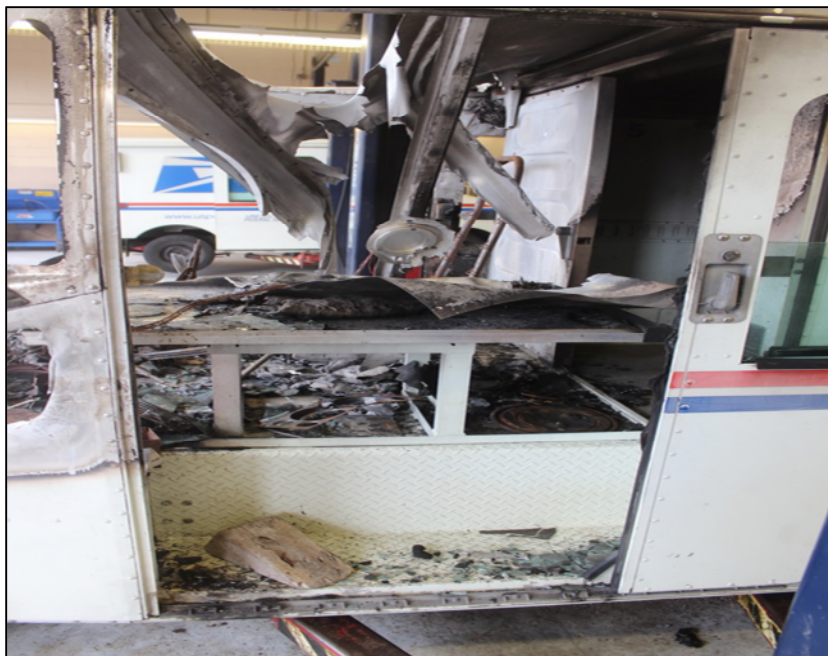
Photograph 7

Mail side interior of LLV, air cleaner cover from engine compartment on floor.

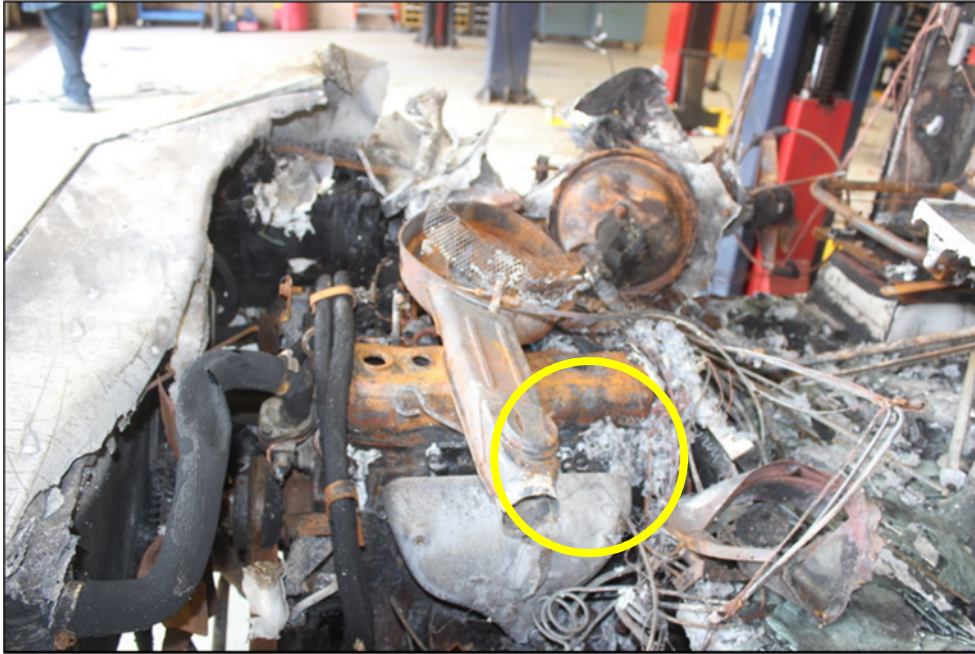
Photograph 8

Engine compartment was area of fire origin.

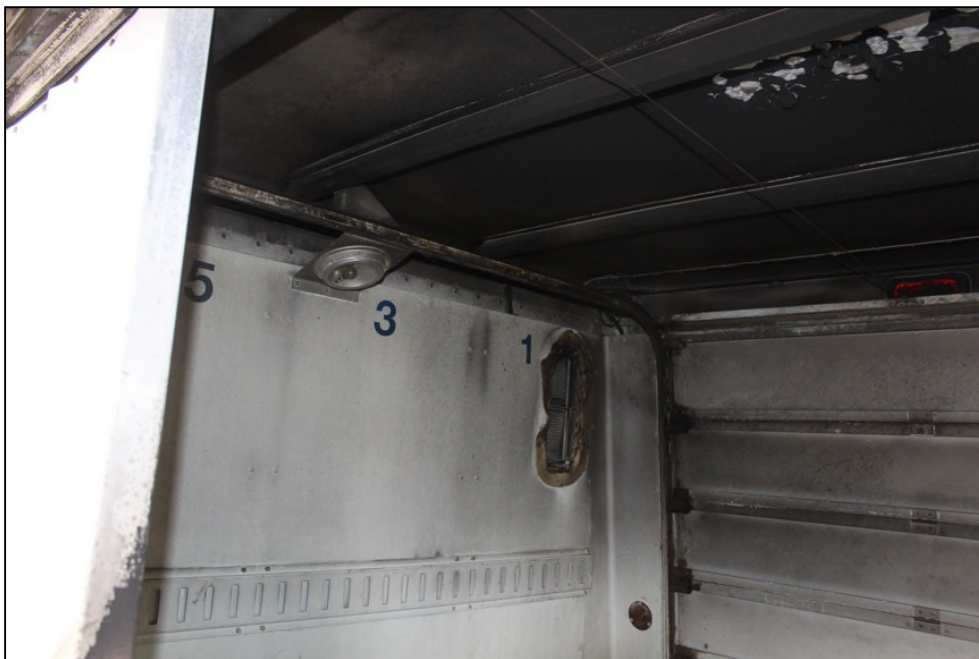
Photograph 9

Smoke staining only in cargo compartment, all mail had been removed.

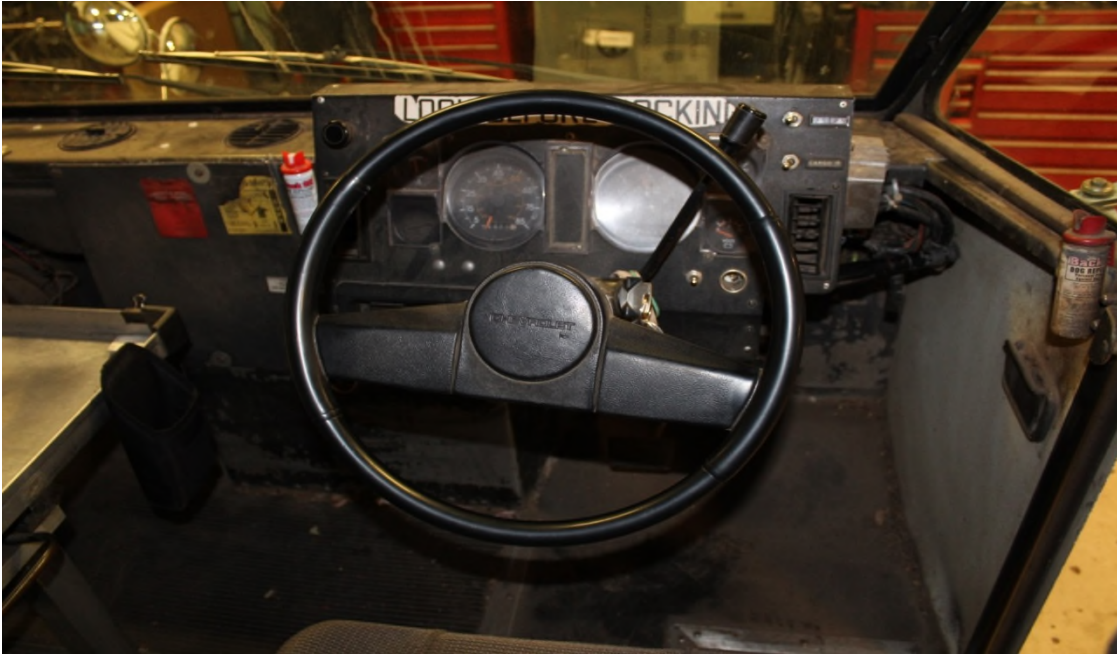
Photograph 5

No damage to the driver's compartment.

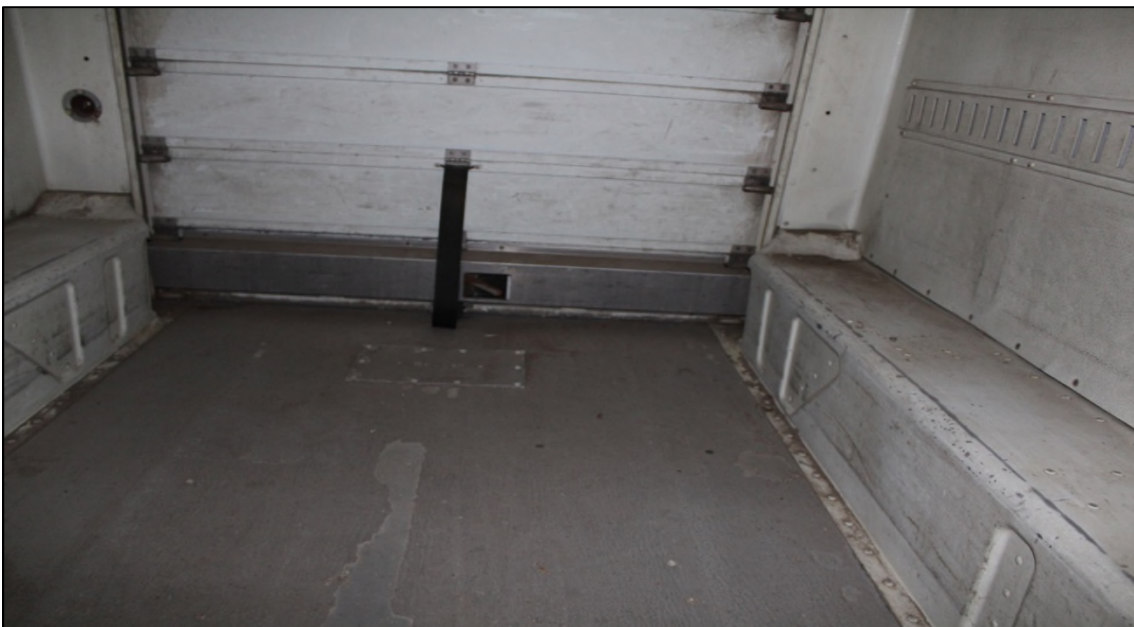
Photograph 6

No damage to the cargo area.

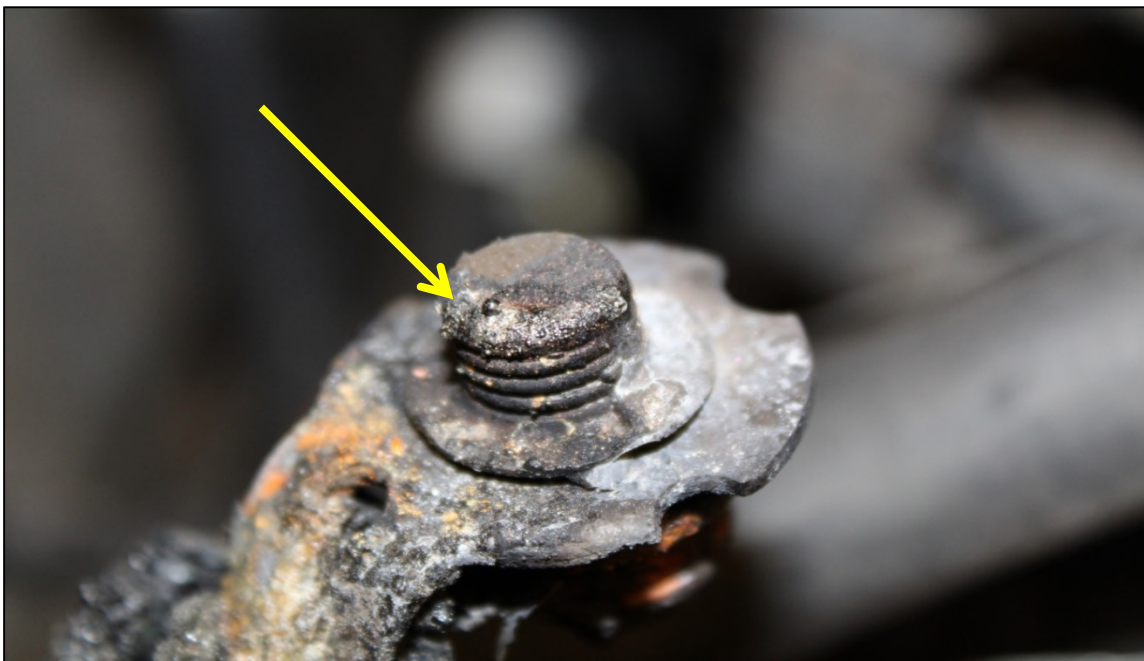
Photograph 10

The battery for the vehicle was located at the front right side of the engine compartment and had moderate fire damage to the left side of the battery at the terminal connection points. The battery, the battery terminals and battery cables were examined and found to be damaged by thermal damage, adverse electrical activity was observed on the battery terminal connection bolt due to a high-resistance connection. The battery and the battery terminals were determined to be the cause of the fire.

Observe the adverse electrical activity to the terminal bolt.

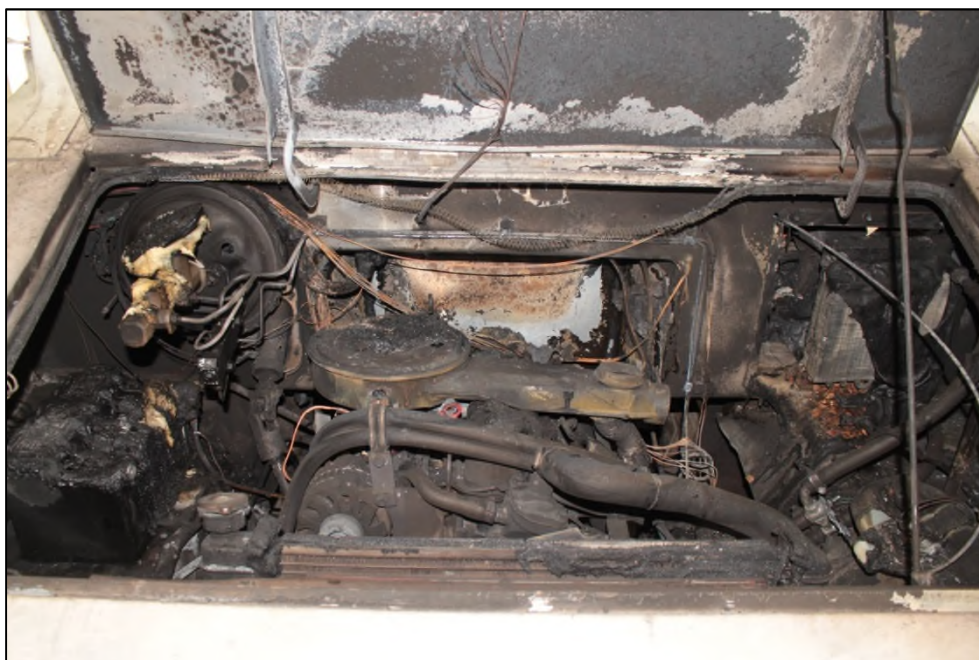
Photograph 2
Engine compartment. Note fire patterns on hood, top.

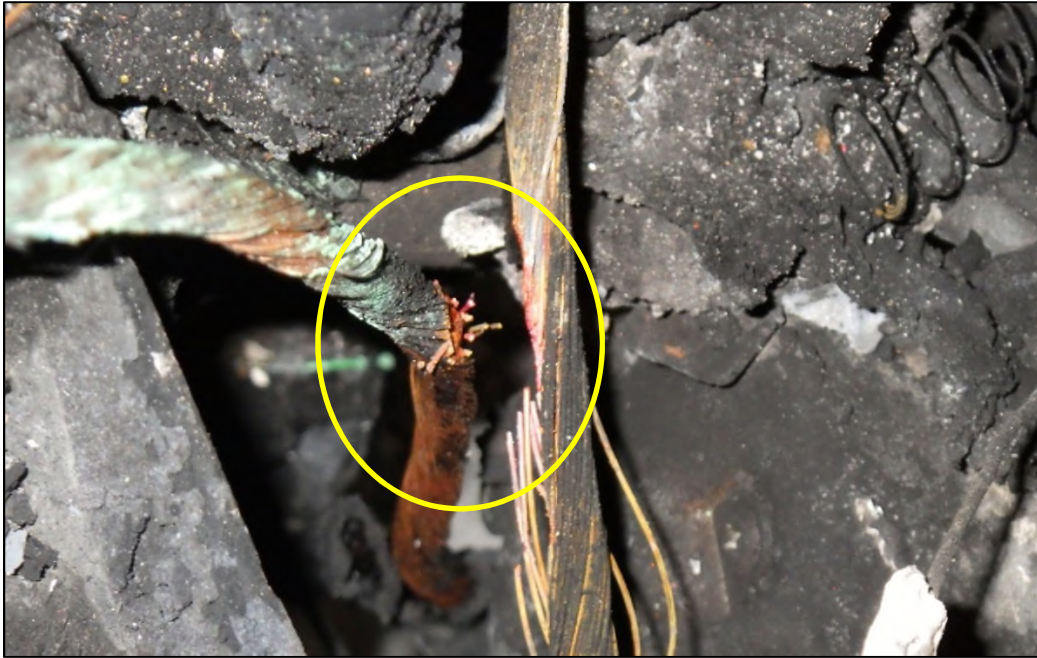
Photograph 3

Positive and negative battery cable leads contacted and arced, yellow circle.

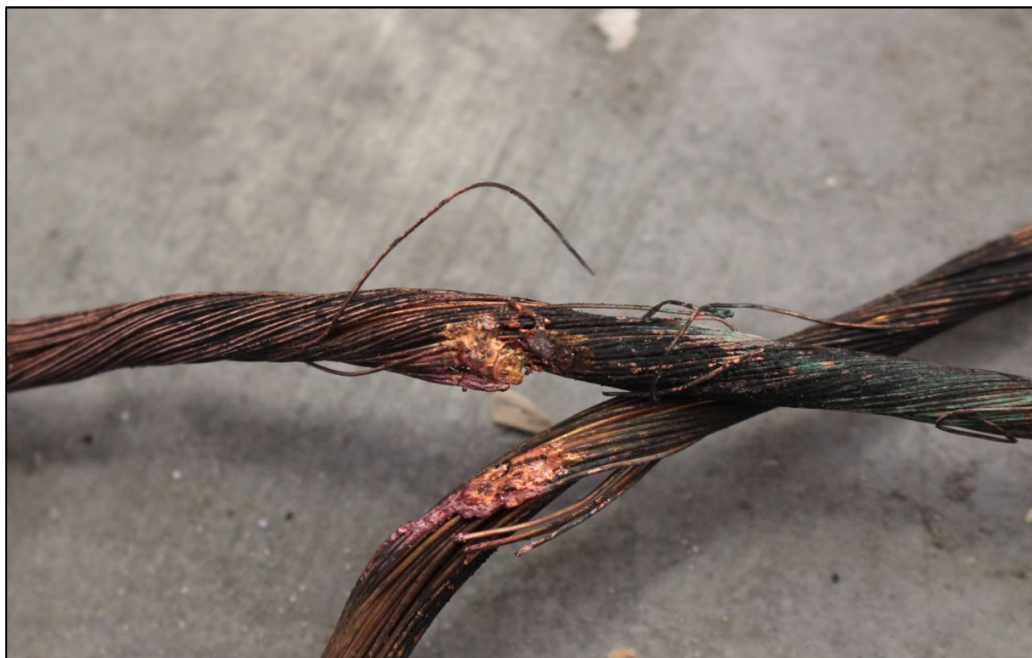
Photograph 4

Positive and negative battery cable leads removed for inspection. Note arcing.

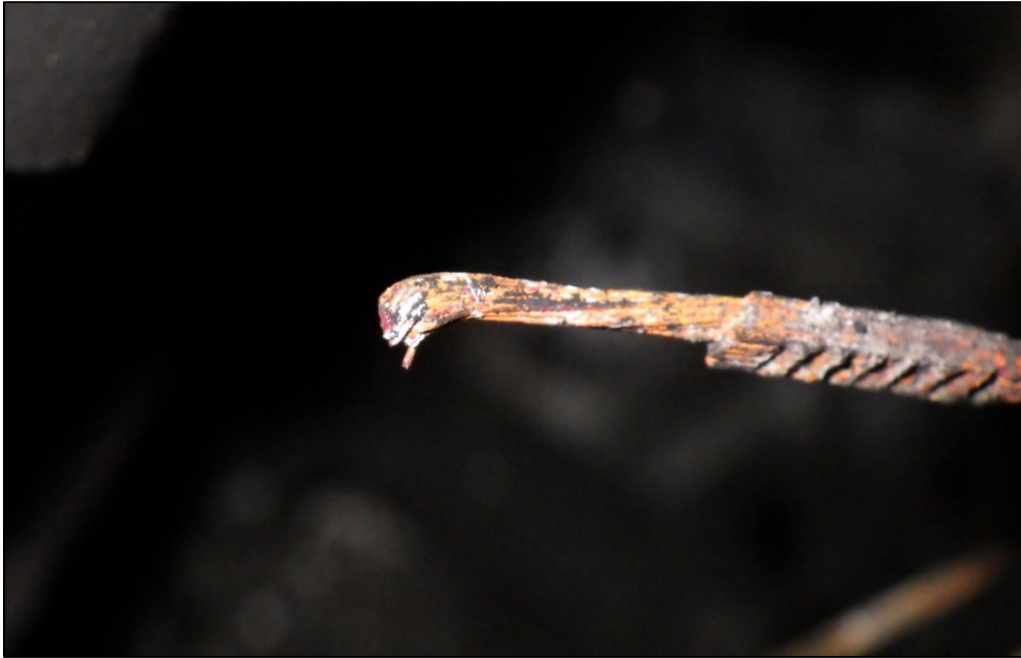
Photograph 5

Adverse electrical activity observed on the wiring harness.

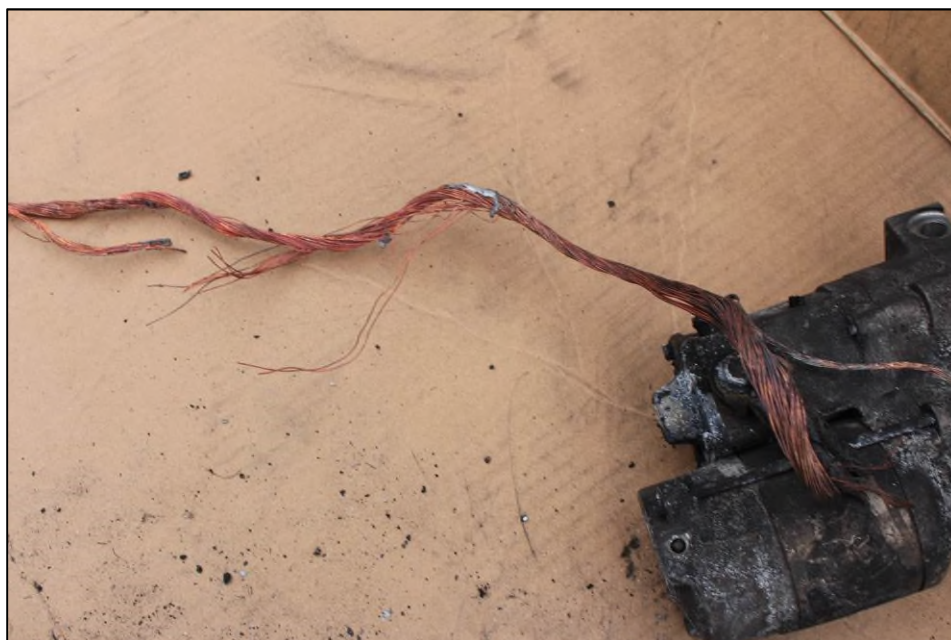
Photograph 14

Starter removed for examination. Wire broken.

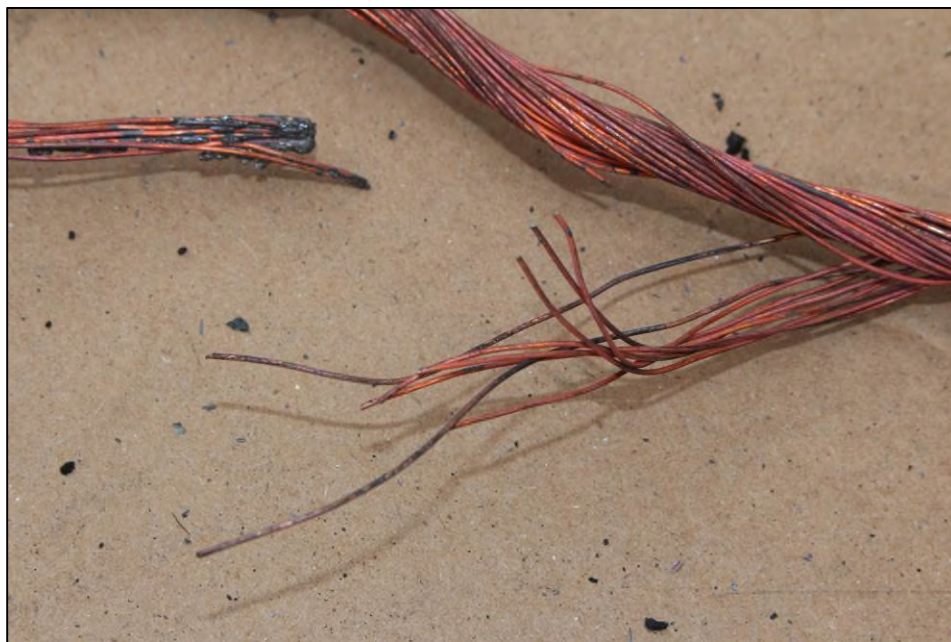
Photograph 15

Closer view of wire for starter.

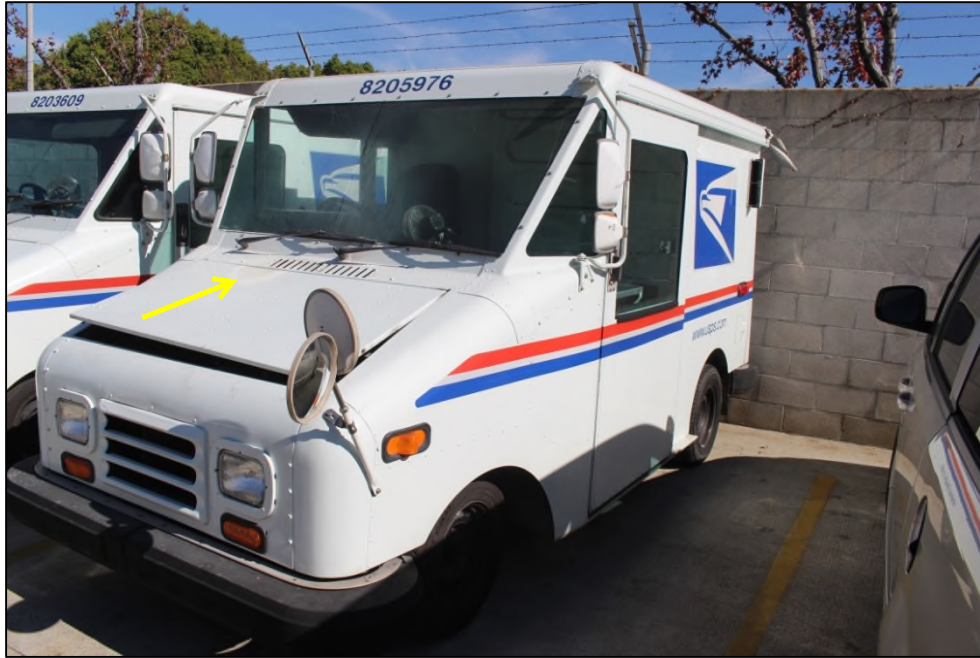
LLV 8205976, Heat mark on hood, yellow arrow.

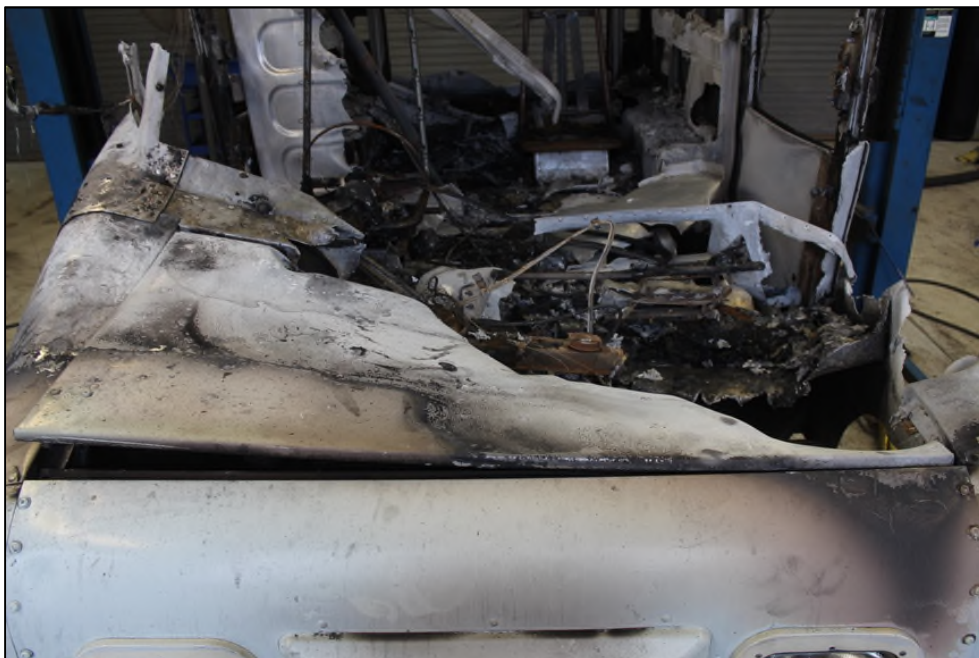
Photograph 6
Hood reconstructed in place over engine compartment.

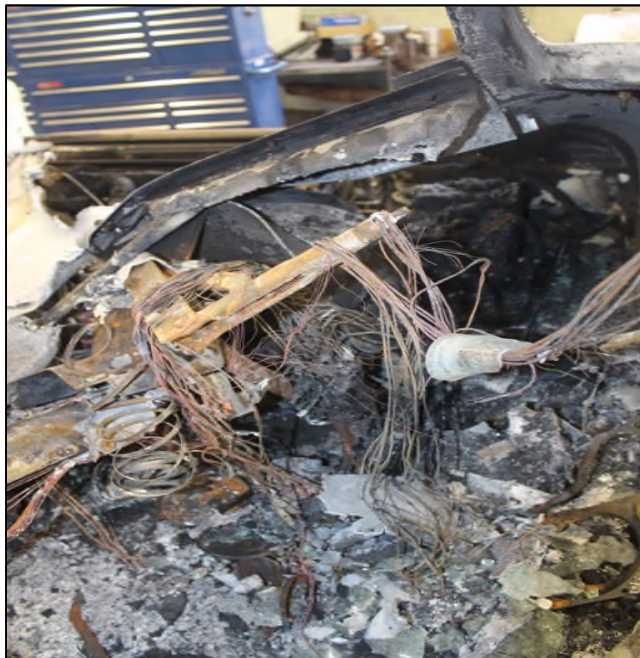
Photograph 8
Remains of fuse panel.

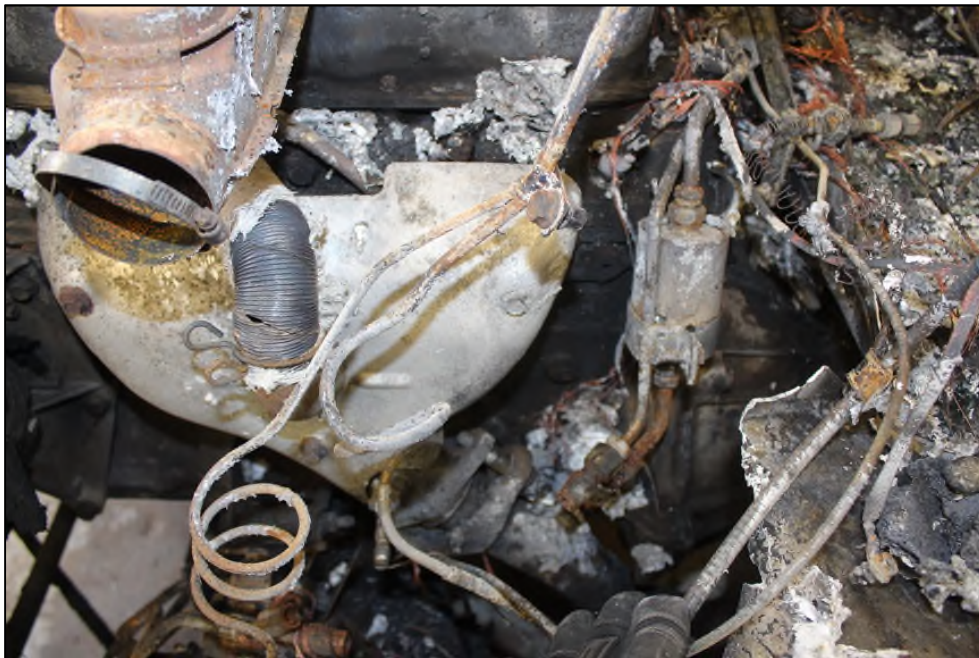
Photograph 12
Area of fire origin left side of engine compartment near fuel lines and filter.

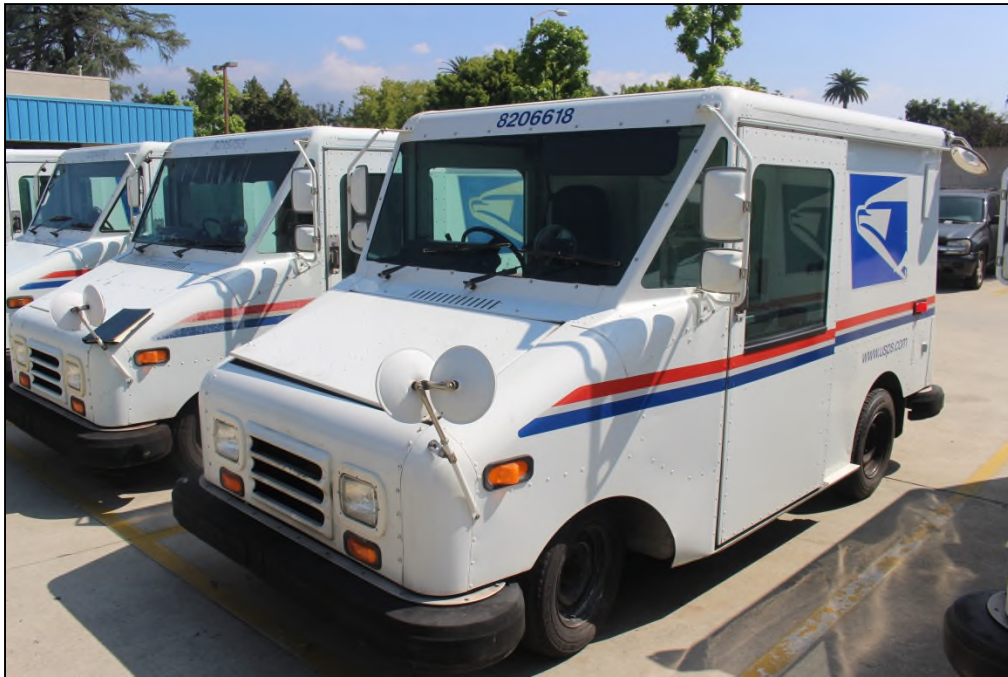
Photograph 1

LLV 8206618, foreground.

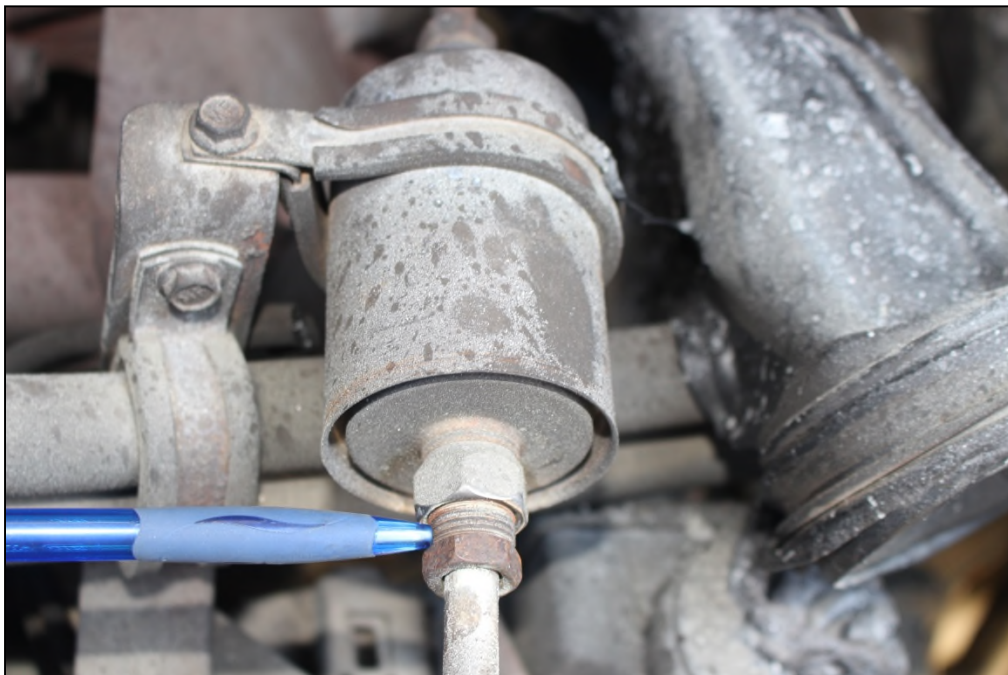
Photograph 4

3. The specific ignition sequence and cause of the fire was determined to be the result of the front fuel line retention nut becoming loose which allowed gasoline to leak and vapors produced to be ignited by the hot surface of the operating engine components.

Engine vibration caused the front fuel line retention nut to loosen at the fuel filter. The filter was mounted on an approximately 6 inch long bracket, which was attached to the power steering pump bracket. The approximately 15 inch long rigid fuel line section attached to the front side of the fuel filter provided leverage during vibration cycles sufficient to loosen the retention nut over time.

Fuel leaking at the fuel line connection generated sufficient vapor to be ignited by an available ignition source.

Closer view of loosened fuel line retention nut indicated by pen.

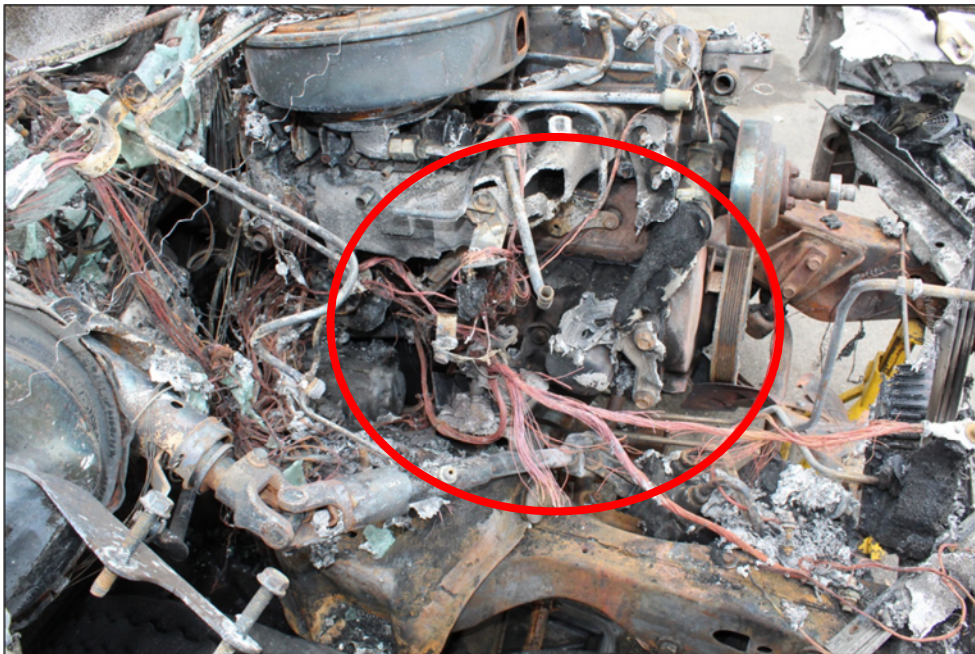
Photograph 6
Area of fire origin (red circle).

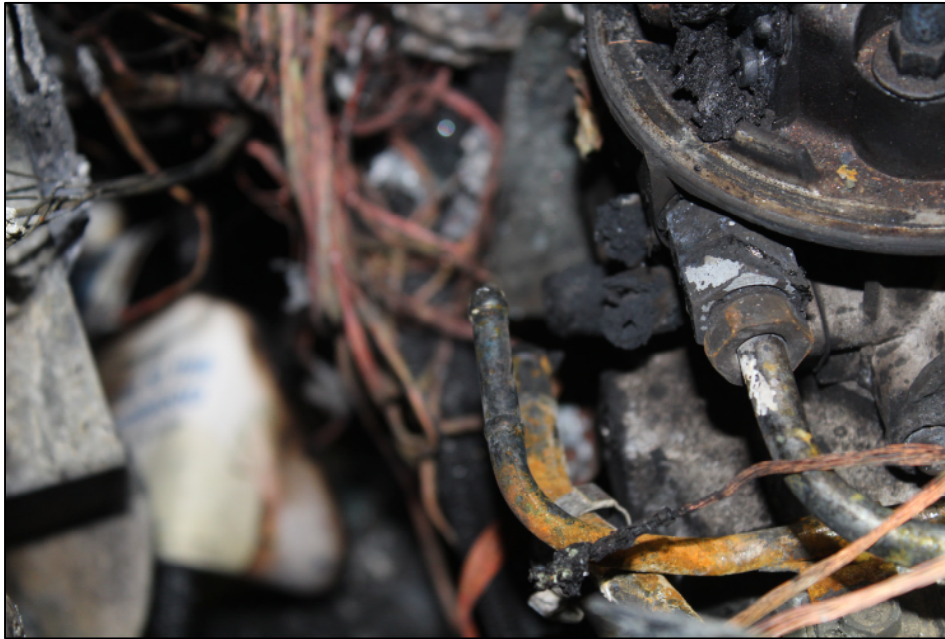
Photograph 3
Remains of fuel lines.

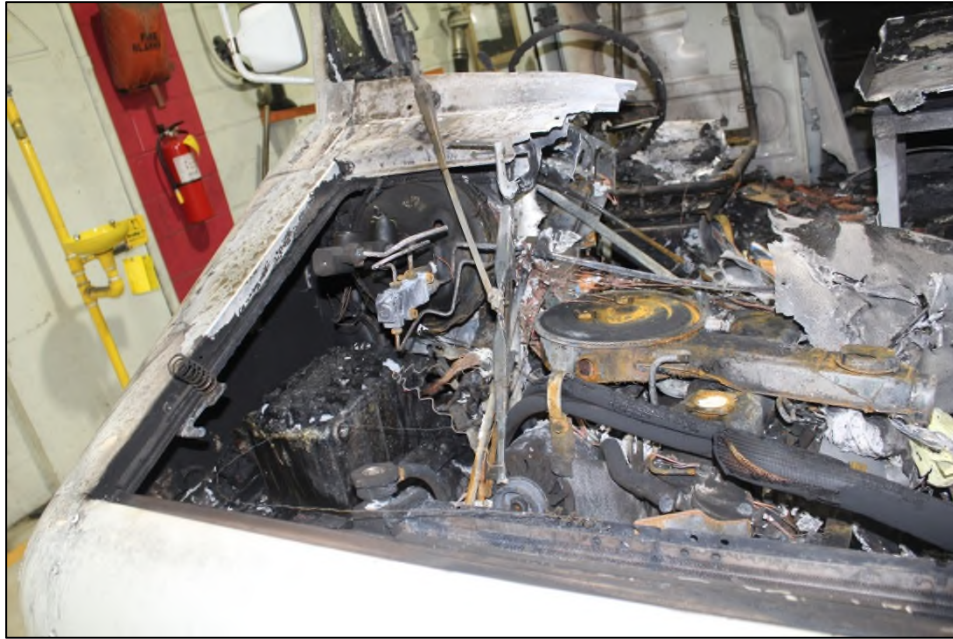
Photograph 5

An overall view of the engine compartment.

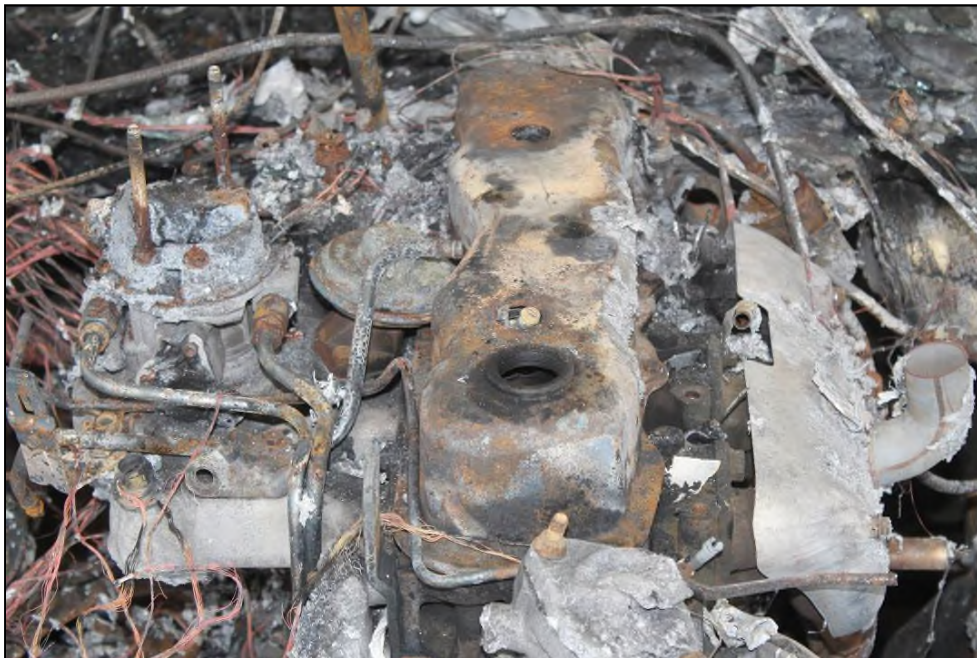
Photograph 2

Top of engine block with air filter removed.
